Supplemental Reprogramming Tool (SRT 8432) Issue: Flash Download Failed

859 Will Flickema Wed, Apr 18, 2018 [Supplemental Reprogramming Tool \(SRT 8432\)](#) 4097

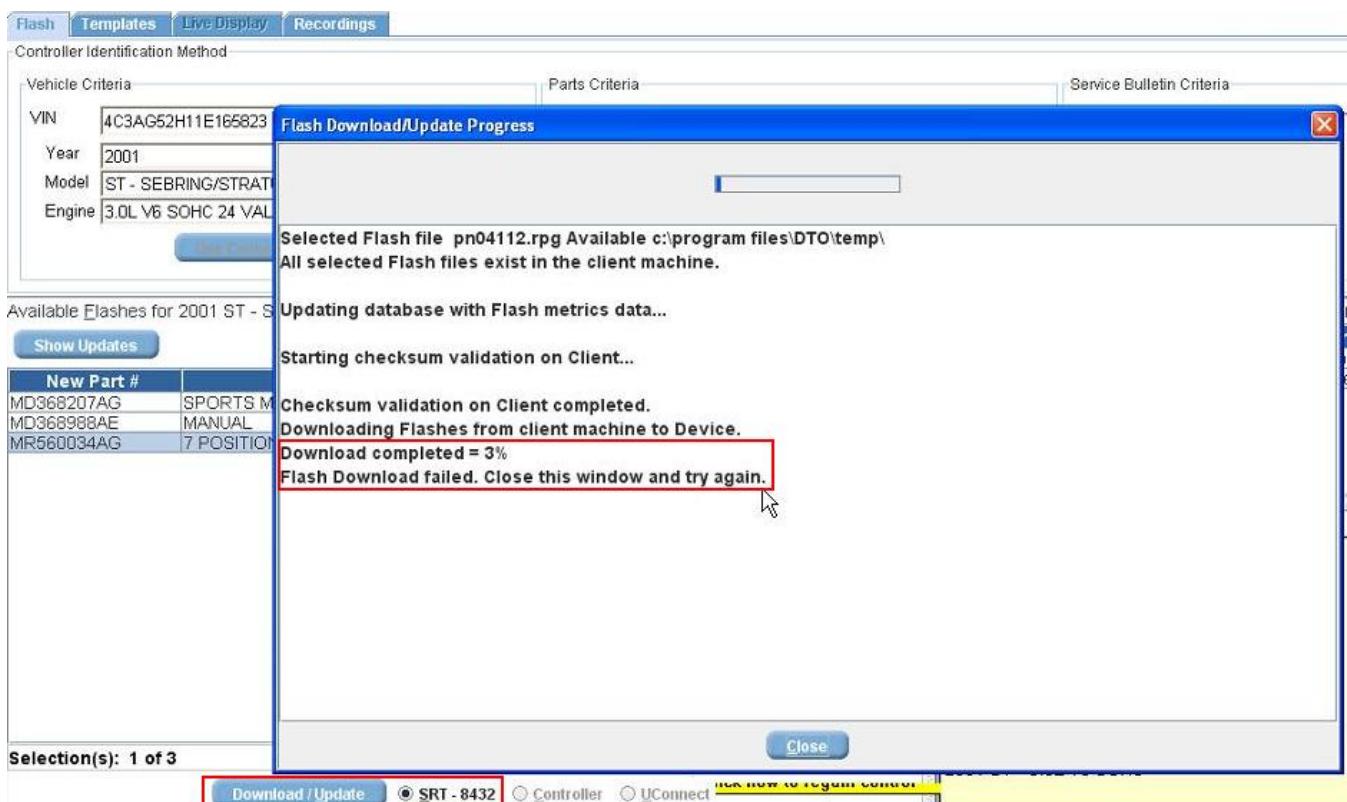
- Some 2001 to 2005 ST22 – Sebring/Stratus 3.0L PCM/ECM flashes require the use of the SRT 8432 device with the TechTOOLs application.
- When selecting the appropriate flash file to download and clicking on download/update, you may receive the message, “Flash Download Failed. Close this window and try again” near 3% of the download complete (see below).

1. Close out of the Flash Download/Update Progress window as prompted above.
2. Click on **Device Options** near the top left of the TechTOOLs application (see below).
3. Select **COM Port Settings**.
