Supplemental Reprogramming Tool (SRT 8432) Issue: Flash Download Failed

859 Will Flickema Wed, Apr 18, 2018 [Supplemental Reprogramming Tool \(SRT 8432\)](#) 4324

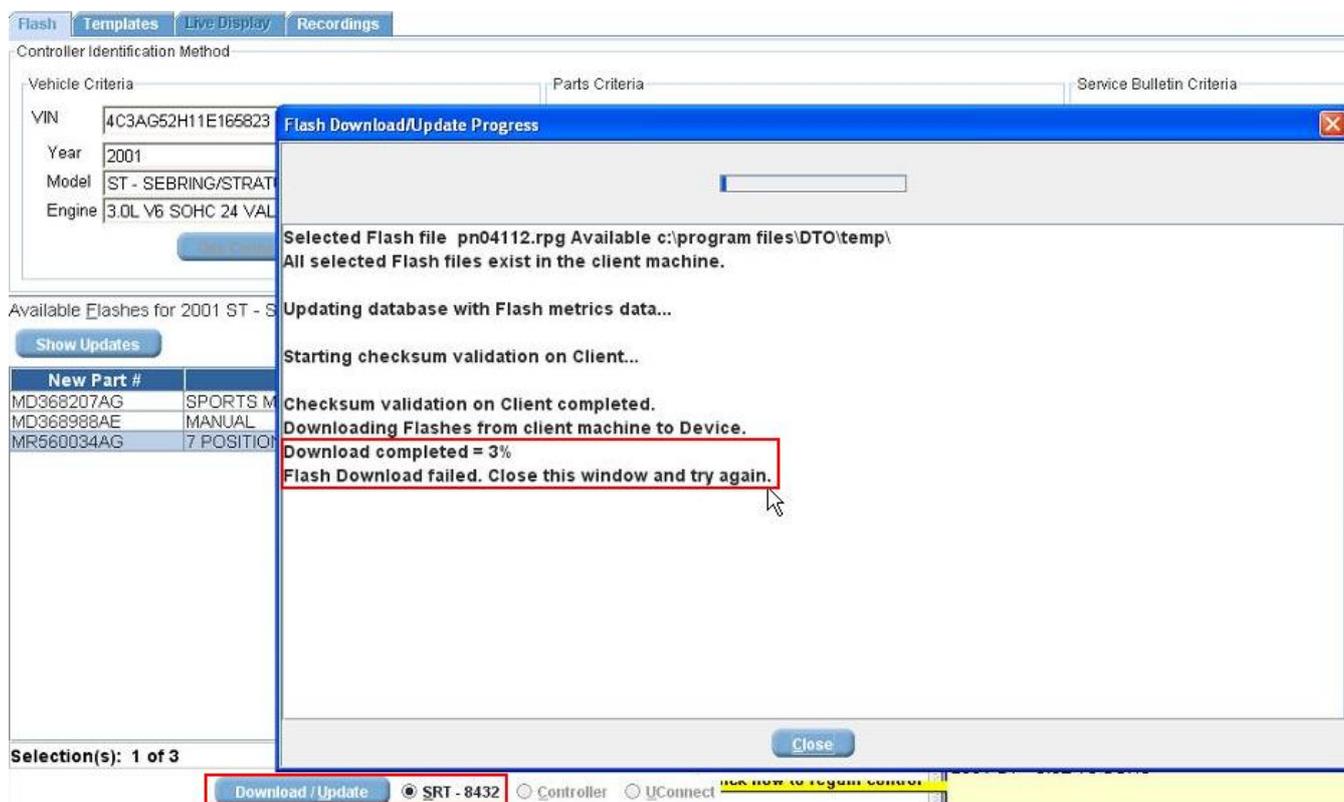
- Some 2001 to 2005 ST22 – Sebring/Stratus 3.0L PCM/ECM flashes require the use of the SRT 8432 device with the TechTOOLS application.
- When selecting the appropriate flash file to download and clicking on download/update, you may receive the message, “Flash Download Failed. Close this window and try again” near 3% of the download complete (see below).

1. Close out of the Flash Download/Update Progress window as prompted above.
2. Click on **Device Options** near the top left of the TechTOOLS application (see below).
3. Select **COM Port Settings**.
