Supplemental Reprogramming Tool (SRT 8432) Issue: Flash Download Failed

859 Will Flickema Wed, Apr 18, 2018 <u>Supplemental Reprogramming Tool (SRT 8432)</u> 3781

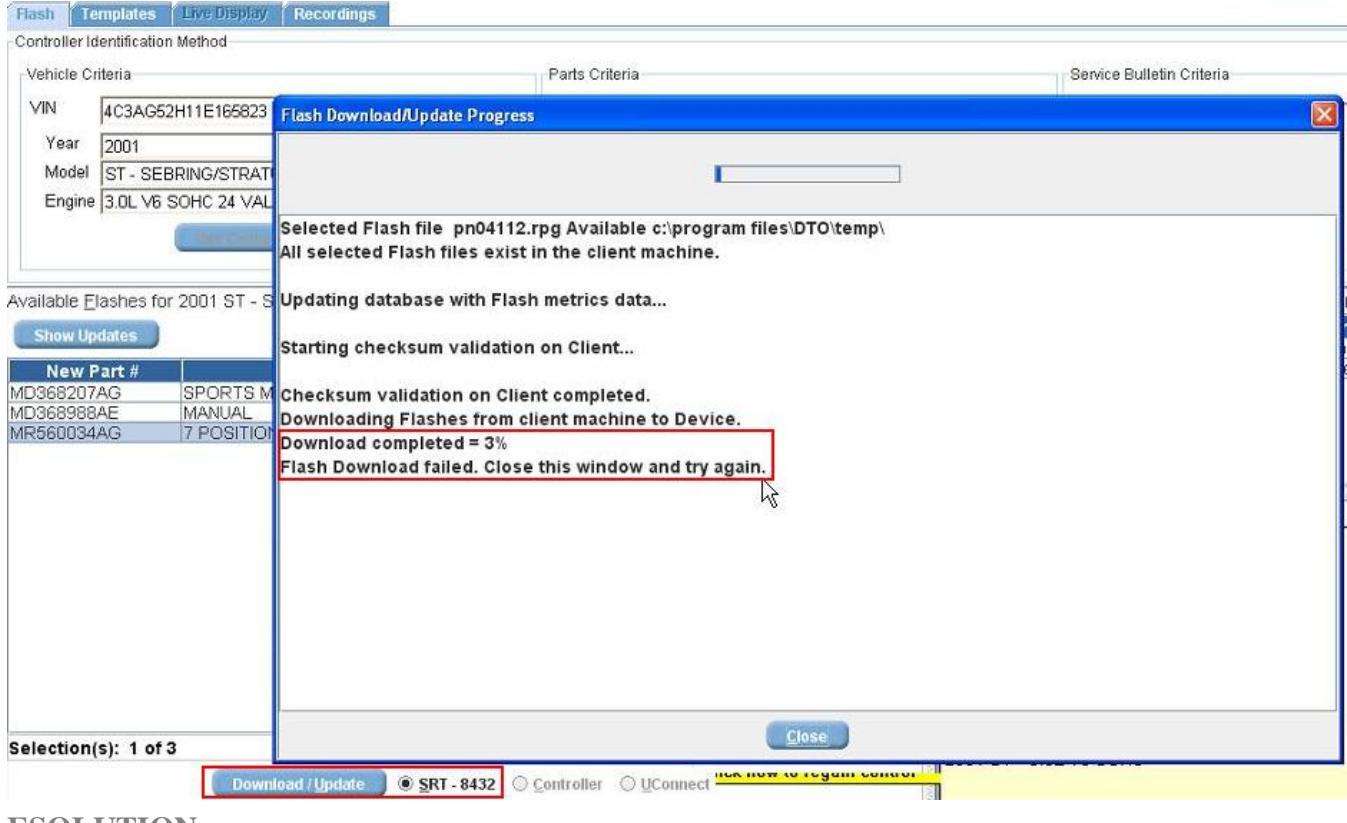
- Some 2001 to 2005 ST22 Sebring/Stratus 3.0L PCM/ECM flashes require the use of the SRT 8432 device with the TechTOOLs application.
- When selecting the appropriate flash file to download and clicking on download/update, you may receive the message, "Flash Download Failed. Close this window and try again" near 3% of the download complete (see below).

- 1. Close out of the Flash Download/Update Progress window as prompted above.
- 2. Click on **Device Options** near the top left of the TechTOOLs application (see below).
- 3. Select COM Port Settings.
