# Supplemental Reprogramming Tool (SRT 8432) Issue: Flash Download Failed

859 Will Flickema Wed, Apr 18, 2018 [Supplemental Reprogramming Tool \(SRT 8432\)](#) 4430

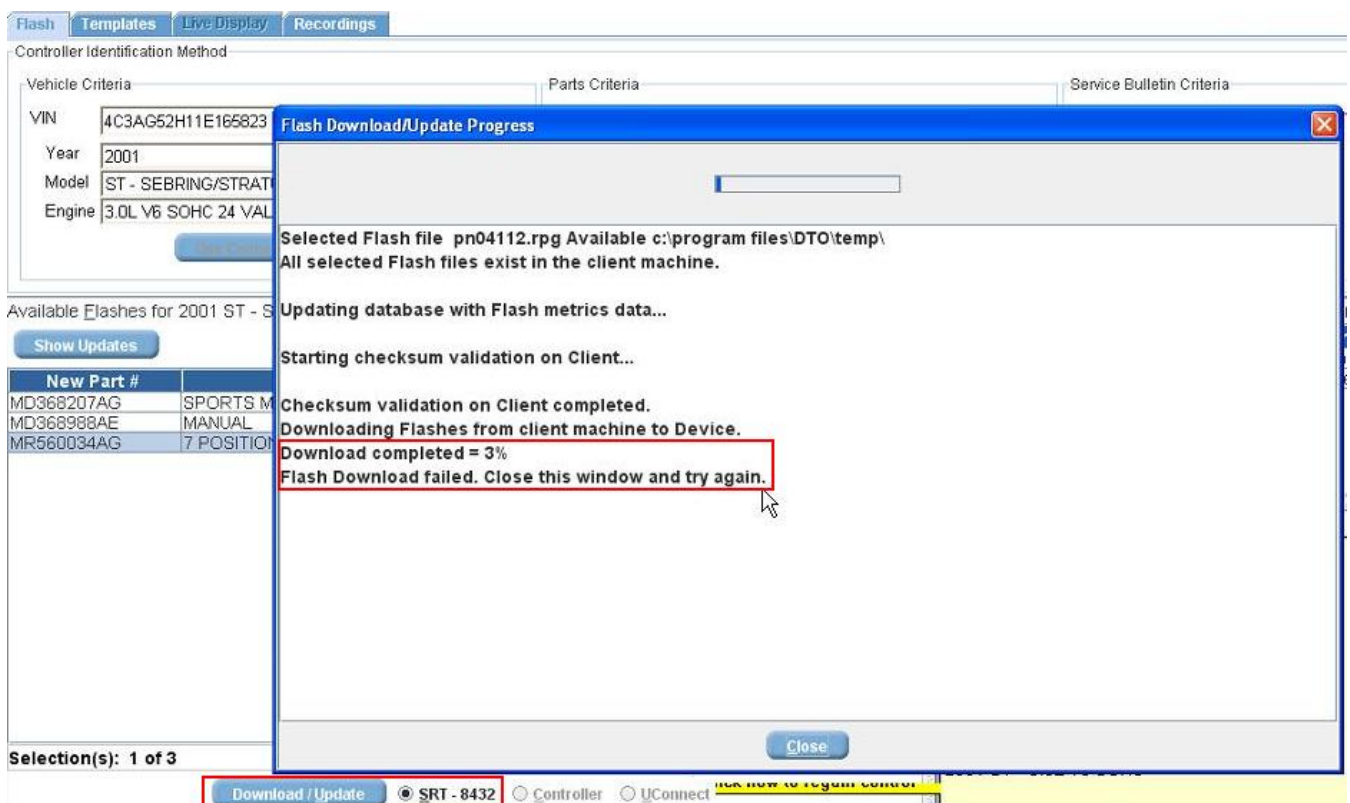
- Some 2001 to 2005 ST22 – Sebring/Stratus 3.0L PCM/ECM flashes require the use of the SRT 8432 device with the TechTOOLS application.
- When selecting the appropriate flash file to download and clicking on download/update, you may receive the message, “Flash Download Failed. Close this window and try again” near 3% of the download complete (see below).
