Supplemental Reprogramming Tool (SRT 8432) Issue: Flash Download Failed

859 Will Flickema Wed, Apr 18, 2018 [Supplemental Reprogramming Tool \(SRT 8432\)](#) 4388

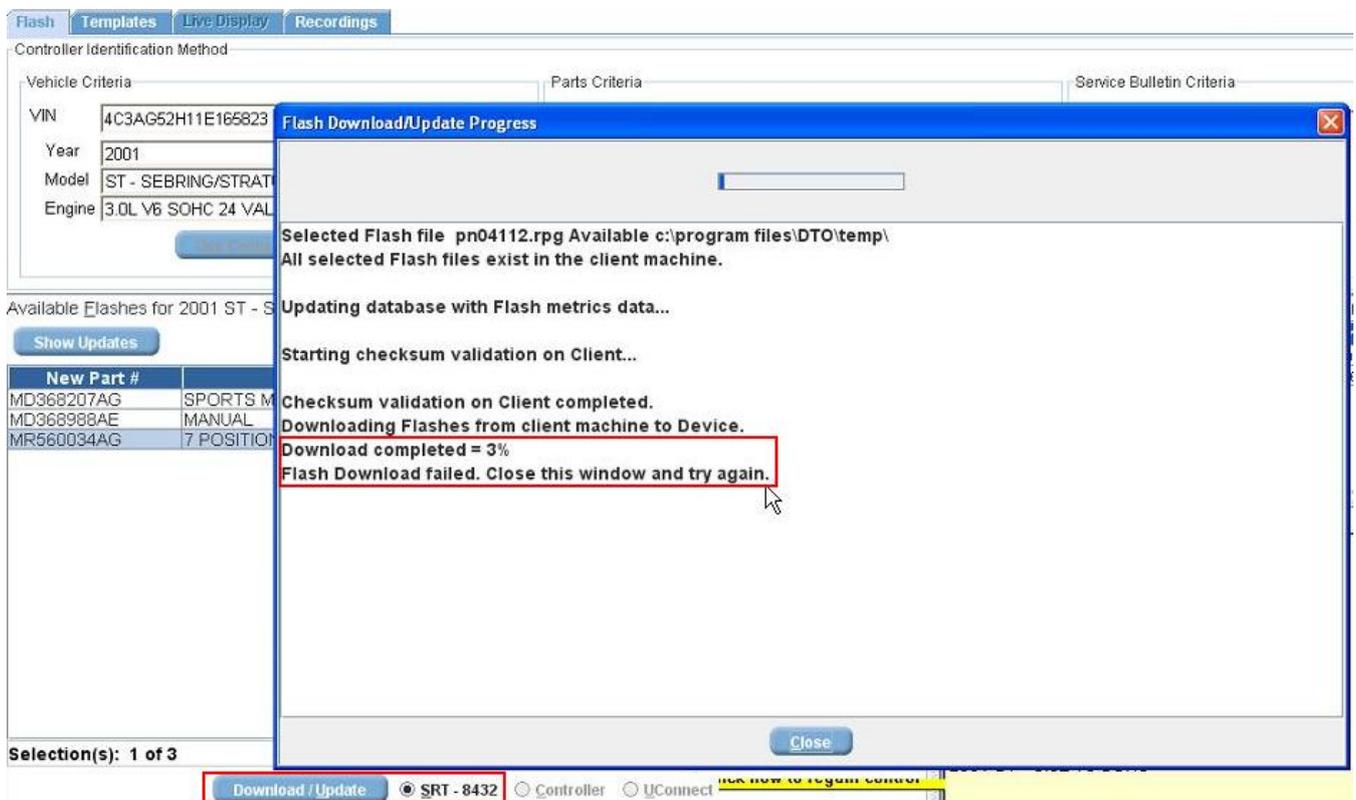
- Some 2001 to 2005 ST22 – Sebring/Stratus 3.0L PCM/ECM flashes require the use of the SRT 8432 device with the TechTOOLS application.
- When selecting the appropriate flash file to download and clicking on download/update, you may receive the message, “Flash Download Failed. Close this window and try again” near 3% of the download complete (see below).

1. Close out of the Flash Download/Update Progress window as prompted above.
2. Click on **Device Options** near the top left of the TechTOOLS application (see below).
3. Select **COM Port Settings**.
