# Supplemental Reprogramming Tool (SRT 8432) Issue: Flash Download Failed

859 Will Flickema Wed, Apr 18, 2018 [Supplemental Reprogramming Tool \(SRT 8432\)](#) 3604

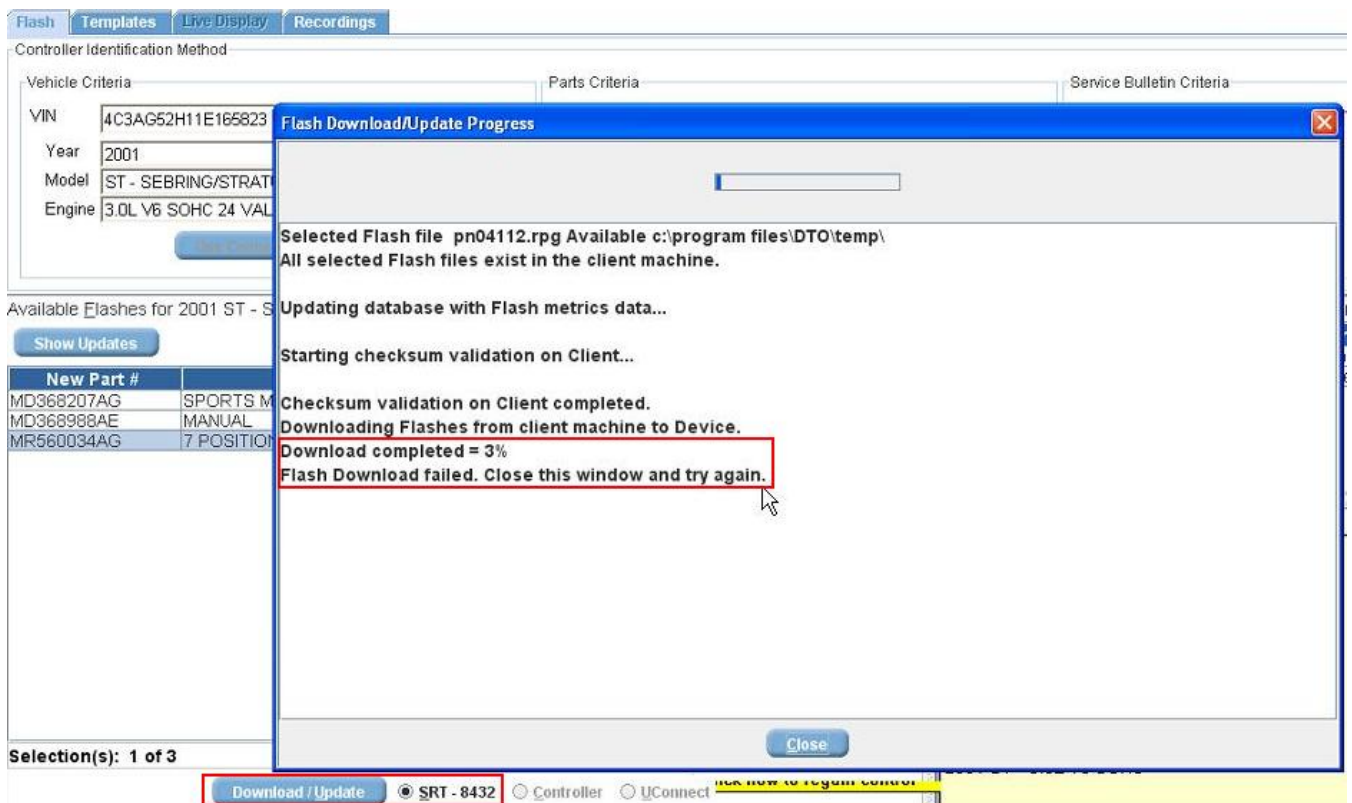
- Some 2001 to 2005 ST22 – Sebring/Stratus 3.0L PCM/ECM flashes require the use of the SRT 8432 device with the TechTOOLS application.
- When selecting the appropriate flash file to download and clicking on download/update, you may receive the message, “Flash Download Failed. Close this window and try again” near 3% of the download complete (see below).

1. Close out of the Flash Download/Update Progress window as prompted above.
2. Click on **Device Options** near the top left of the TechTOOLS application (see below).
3. Select **COM Port Settings**.
