# Supplemental Reprogramming Tool (SRT 8432) Issue: Flash Download Failed

859 Will Flickema Wed, Apr 18, 2018 [Supplemental Reprogramming Tool \(SRT 8432\)](#) 3745

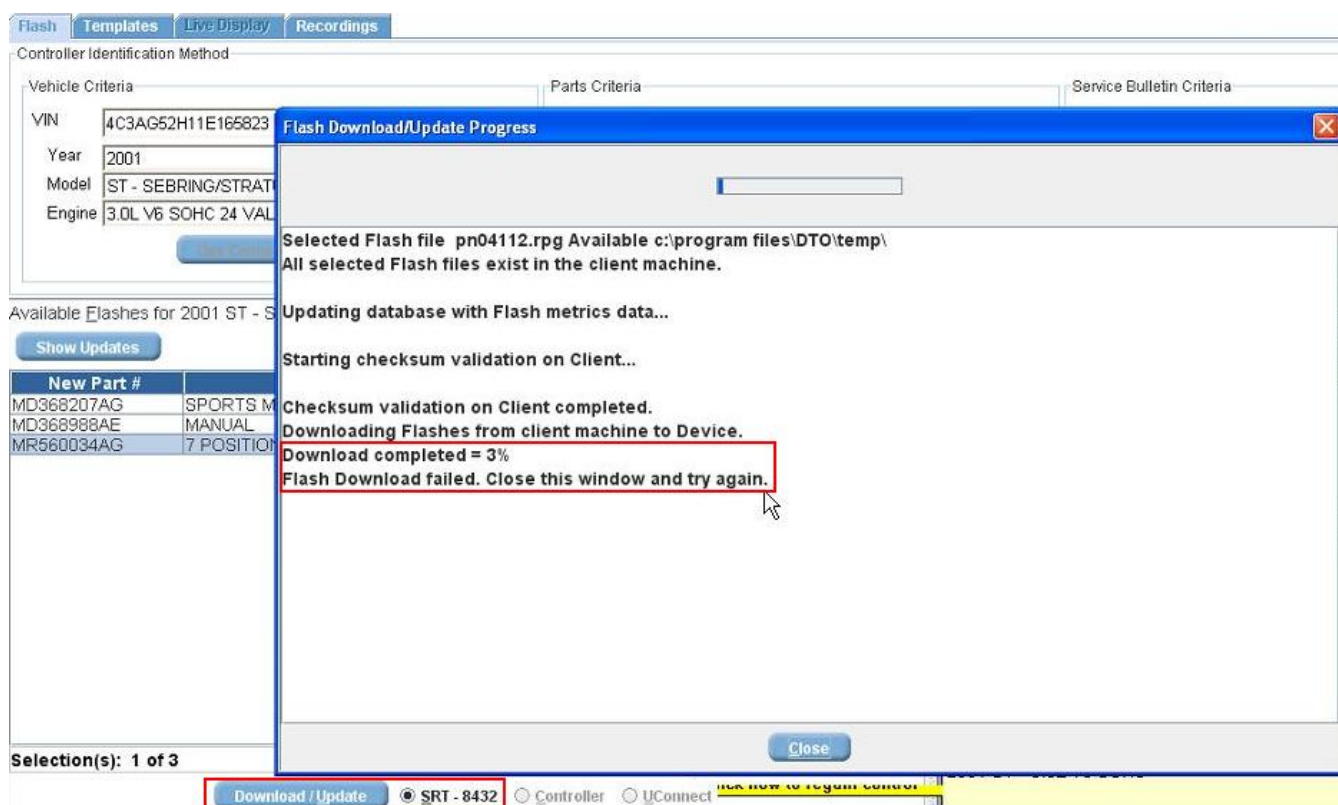
- Some 2001 to 2005 ST22 – Sebring/Stratus 3.0L PCM/ECM flashes require the use of the SRT 8432 device with the TechTOOLS application.
- When selecting the appropriate flash file to download and clicking on download/update, you may receive the message, “Flash Download Failed. Close this window and try again” near 3% of the download complete (see below).
