Supplemental Reprogramming Tool (SRT 8432) Issue: Flash Download Failed

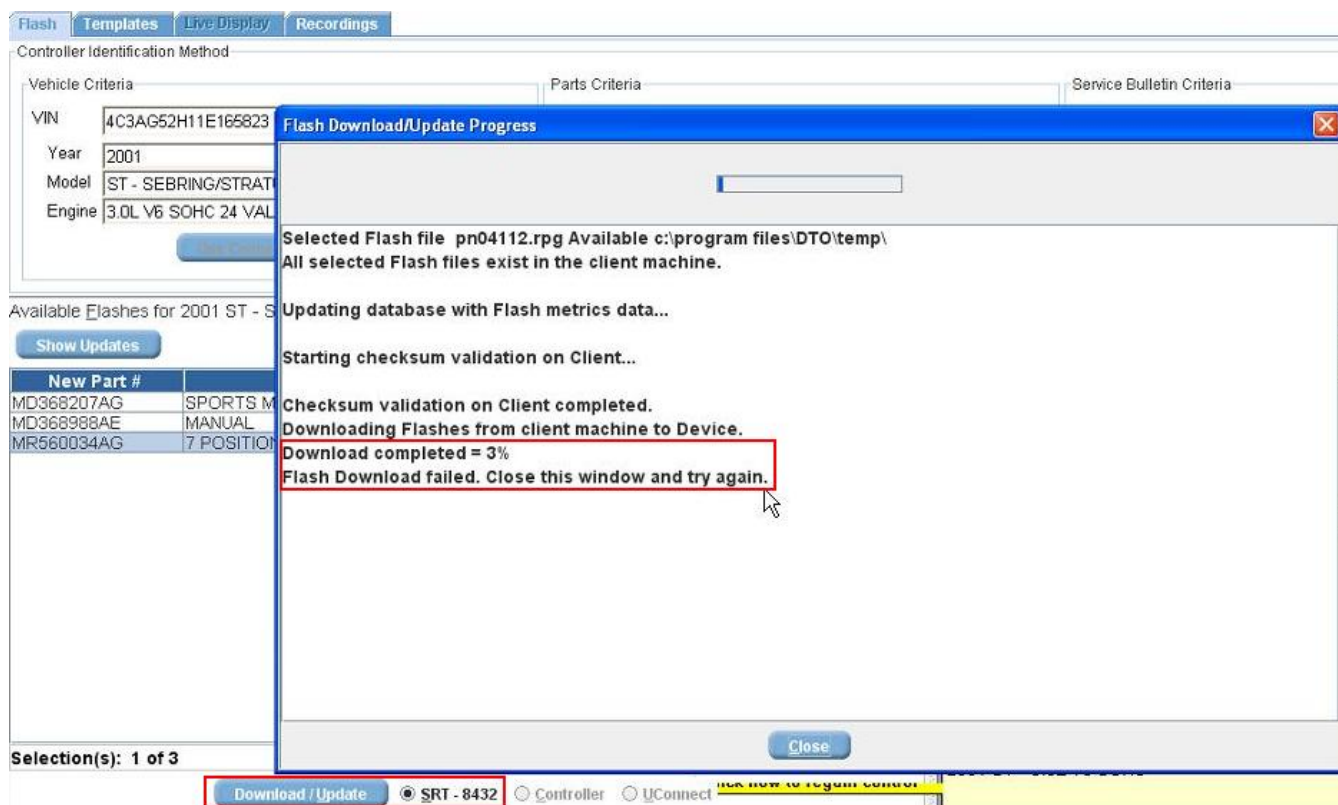
- Some 2001 to 2005 ST22 – Sebring/Stratus 3.0L PCM/ECM flashes require the use of the SRT 8432 device with the TechTOOLS application.
- When selecting the appropriate flash file to download and clicking on download/update, you may receive the message, “Flash Download Failed. Close this window and try again” near 3% of the download complete (see below).

1. Close out of the Flash Download/Update Progress window as prompted above.
2. Click on **Device Options** near the top left of the TechTOOLS application (see below).
3. Select **COM Port Settings**.
