Supplemental Reprogramming Tool (SRT 8432) Issue: Flash Download Failed

859 Will Flickema Wed, Apr 18, 2018 Supplemental Reprogramming Tool (SRT 8432) 4669

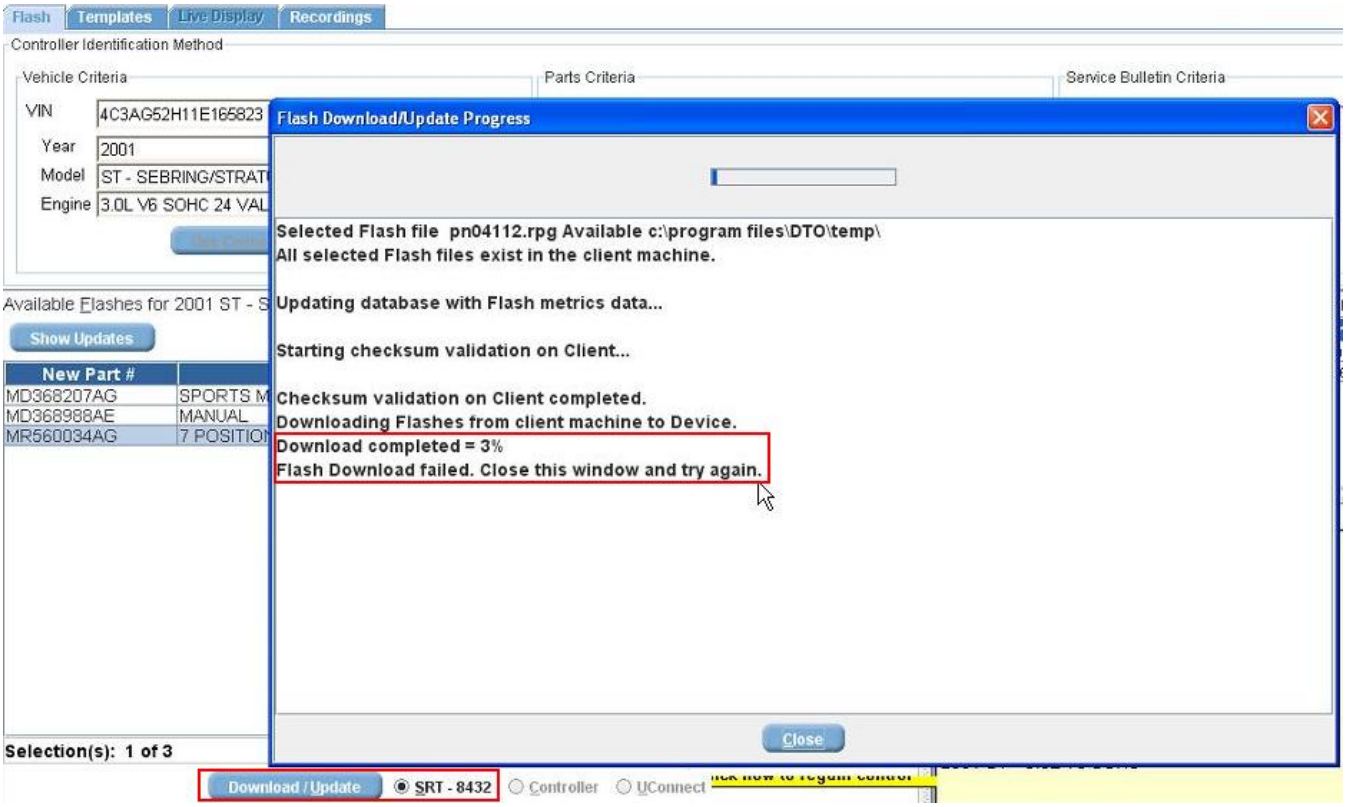
- Some 2001 to 2005 ST22 – Sebring/Stratus 3.0L PCM/ECM flashes require the use of the SRT 8432 device with the TechTOOLs application.
- When selecting the appropriate flash file to download and clicking on download/update, you may receive the message, “Flash Download Failed. Close this window and try again” near 3% of the download complete (see below).

1. Close out of the Flash Download/Update Progress window as prompted above.
2. Click on **Device Options** near the top left of the TechTOOLs application (see below).
3. Select **COM Port Settings**.
